# INVISIBLE UPGRADES

**SOME SAY YOU CAN'T HAVE EVERYTHING, BUT THE OWNERS OF THIS FAMOUS HISTORIC HOUSE FOUND A WAY TO IMPROVE THEIR HOME'S LIVABILITY WITHOUT SACRIFICING THE BUILDING'S INTEGRITY.**

Acquiring a Case Study House such as #26, in almost original condition, is a once in a lifetime opportunity. The only Case Study House to be built in Northern California, #26 was designed by architect Beverley David Thorn and completed in 1963. Since then, the house has only changed hands once.

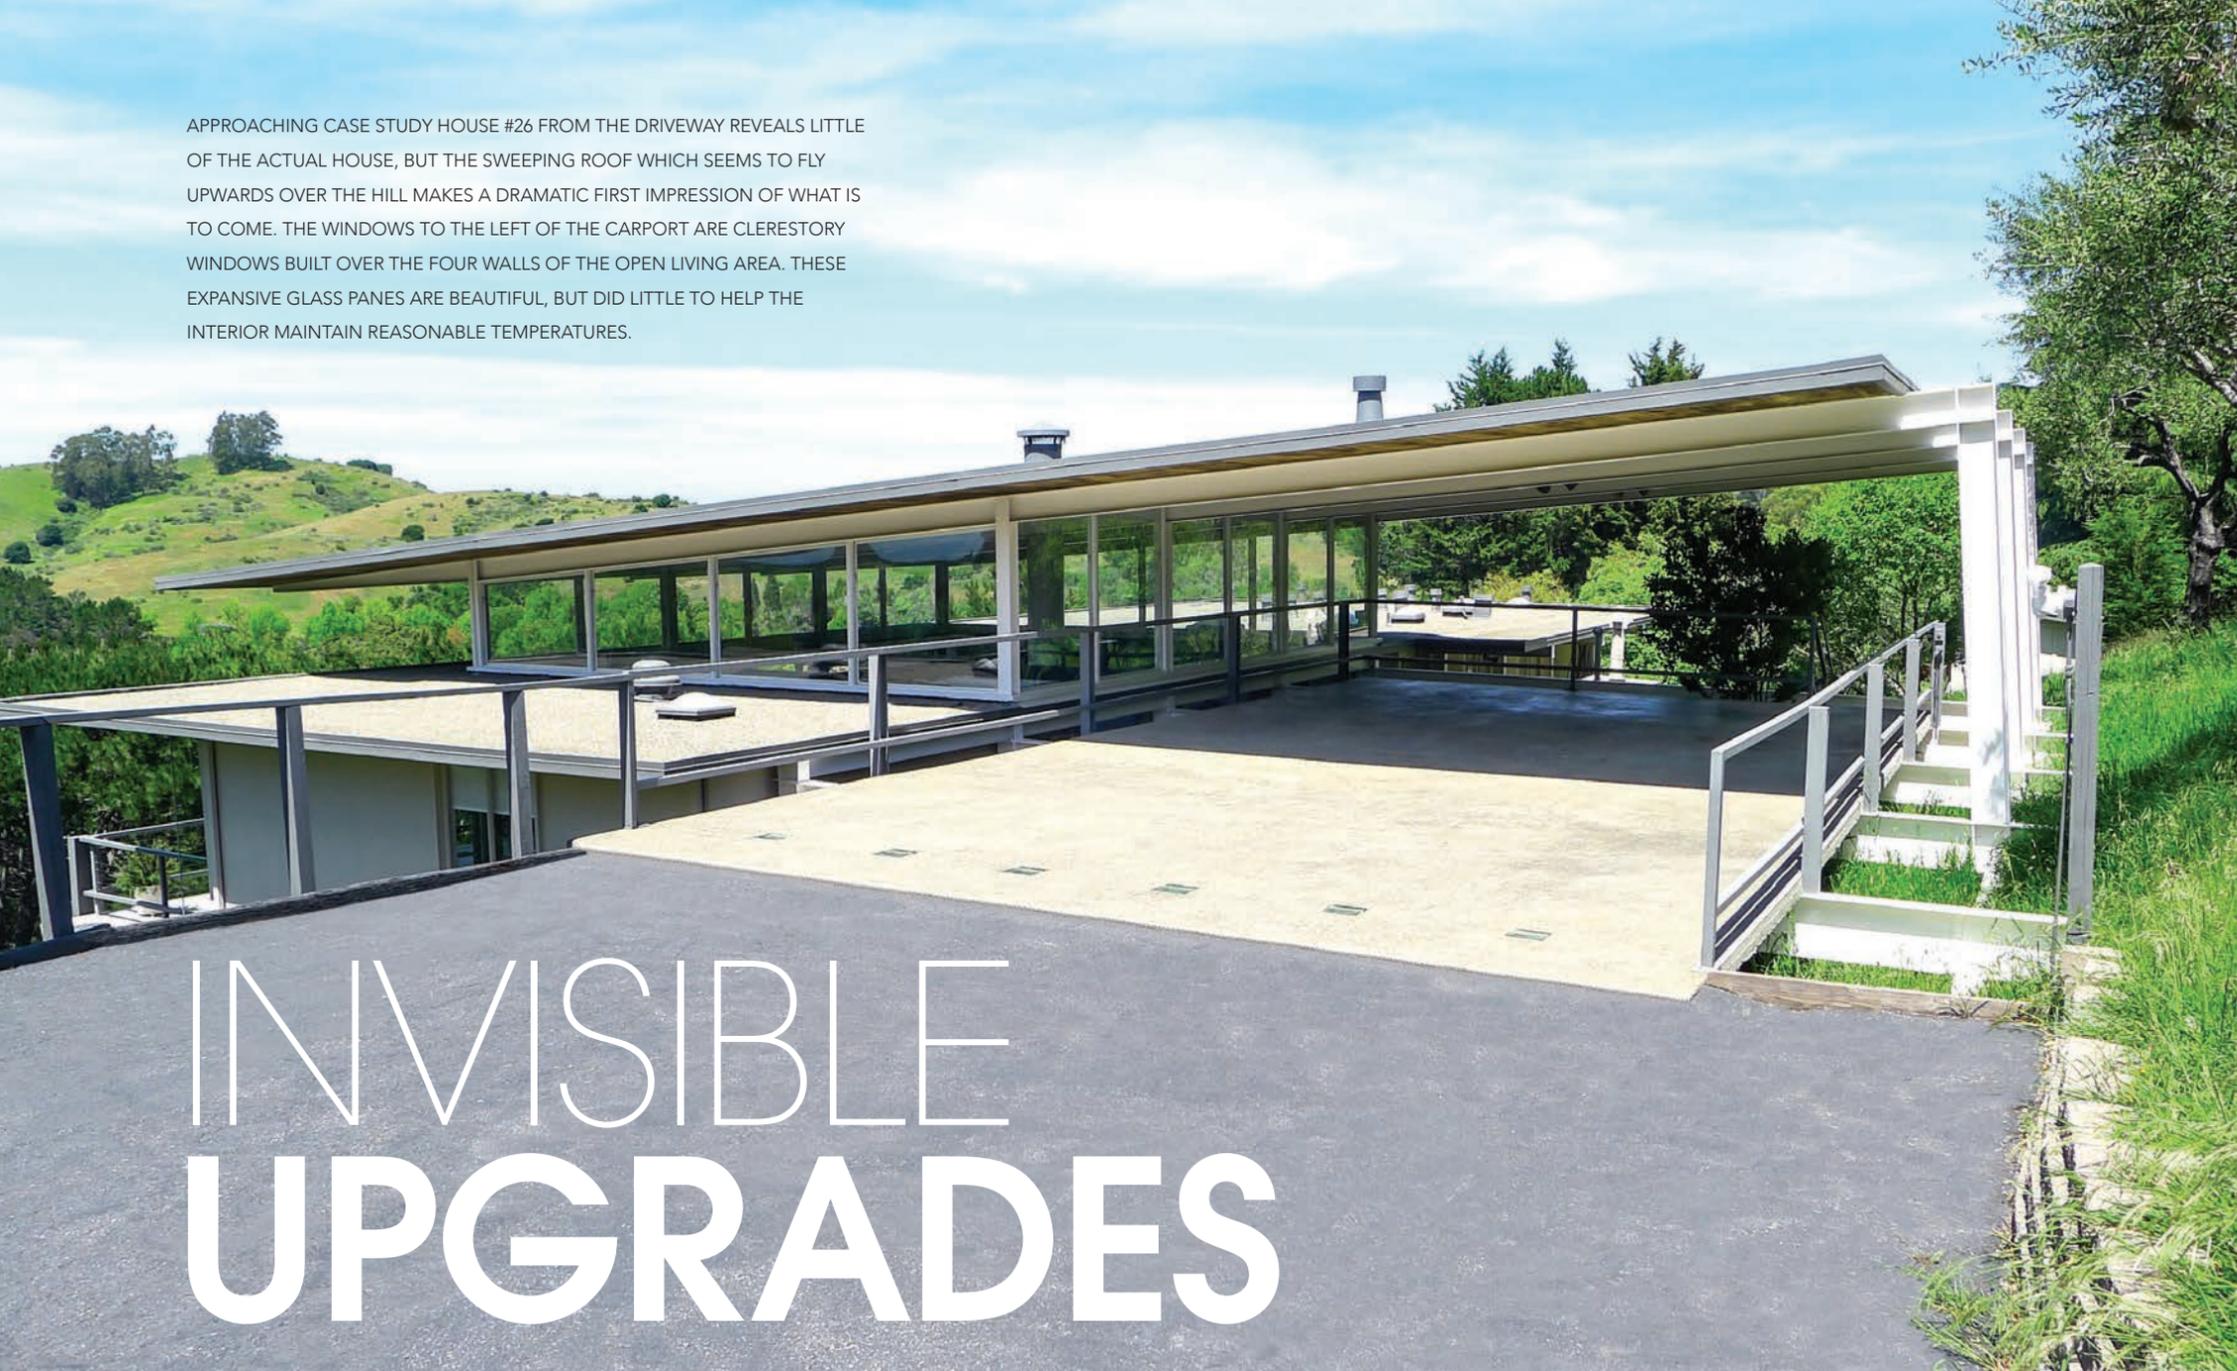
APPROACHING CASE STUDY HOUSE #26 FROM THE DRIVEWAY REVEALS LITTLE OF THE ACTUAL HOUSE, BUT THE SWEEPING ROOF WHICH SEEMS TO FLY UPWARDS OVER THE HILL MAKES A DRAMATIC FIRST IMPRESSION OF WHAT IS TO COME. THE WINDOWS TO THE LEFT OF THE CARPORT ARE CLERESTORY WINDOWS BUILT OVER THE FOUR WALLS OF THE OPEN LIVING AREA. THESE EXPANSIVE GLASS PANES ARE BEAUTIFUL, BUT DID LITTLE TO HELP THE INTERIOR MAINTAIN REASONABLE TEMPERATURES.

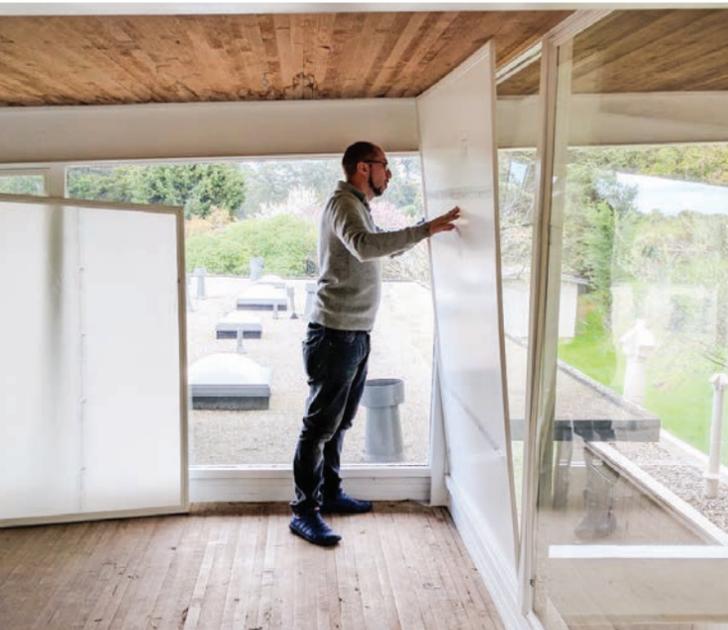
(LEFT) MEASURE TWICE, THEN INSTALL. THE ACRYLIC PANELS ARE COVERED IN A PROTECTIVE FILM TO AVOID SCRATCHES OR FINGERPRINTS UNTIL THEY ARE INSTALLED. THE INSTALLATION PROCESS IS A SIMPLE MATTER OF LINING UP THE ANGLES AND REMOVING THE FILM. ONCE IN PLACE, THE INSERTS WILL BLEND SEAMLESSLY INTO THE CURRENT WINDOW CASINGS.

Similar, but superior, to double paned glass windows, Indow inserts are designed to improve insulation, increase privacy and reduce noise. Cord chose the company's Museum Grade model, which is also designed to provide protection against harmful UV rays that can fade colors and damage artwork. Most importantly, the inserts do not hinder the view outside or change the quality of light that comes inside.

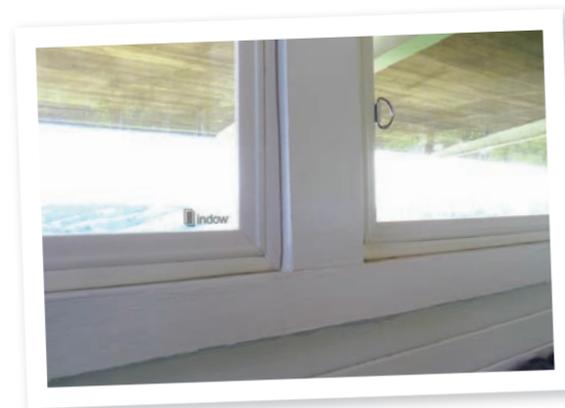
(ABOVE) THESE INSERTS DO NOT REQUIRE ANY KIND OF INVASIVE FIXATIVE TO HOLD THEM IN PLACE. INSTEAD, THEY RELY ON TENSION FROM THE FRAME WHICH SURROUNDS THE ACRYLIC PANEL. THESE PANELS WILL BE JUST AS EASY TO REMOVE AS THEY WERE TO INSTALL.

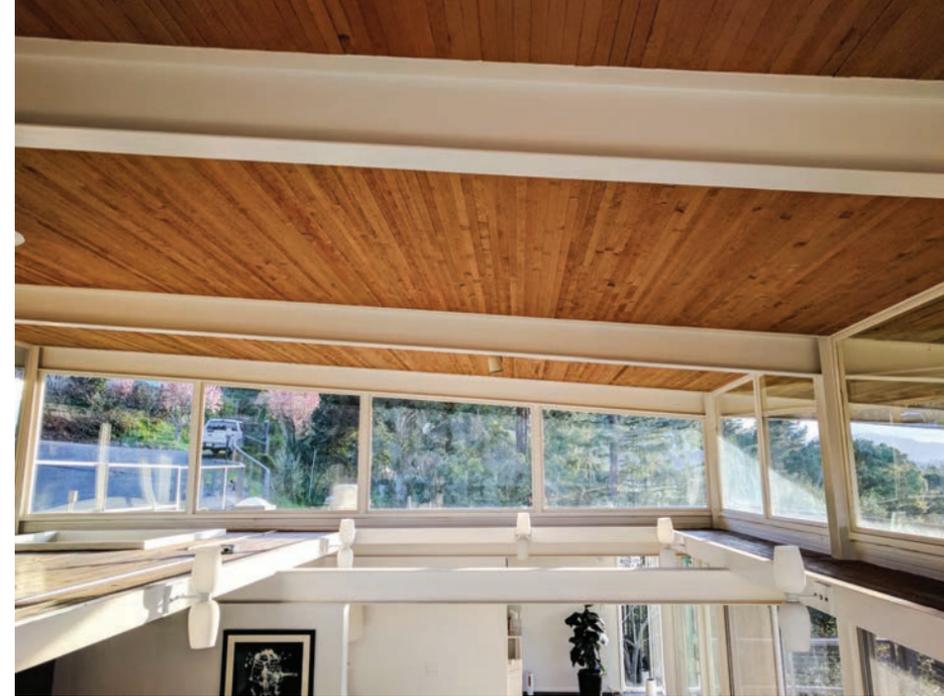
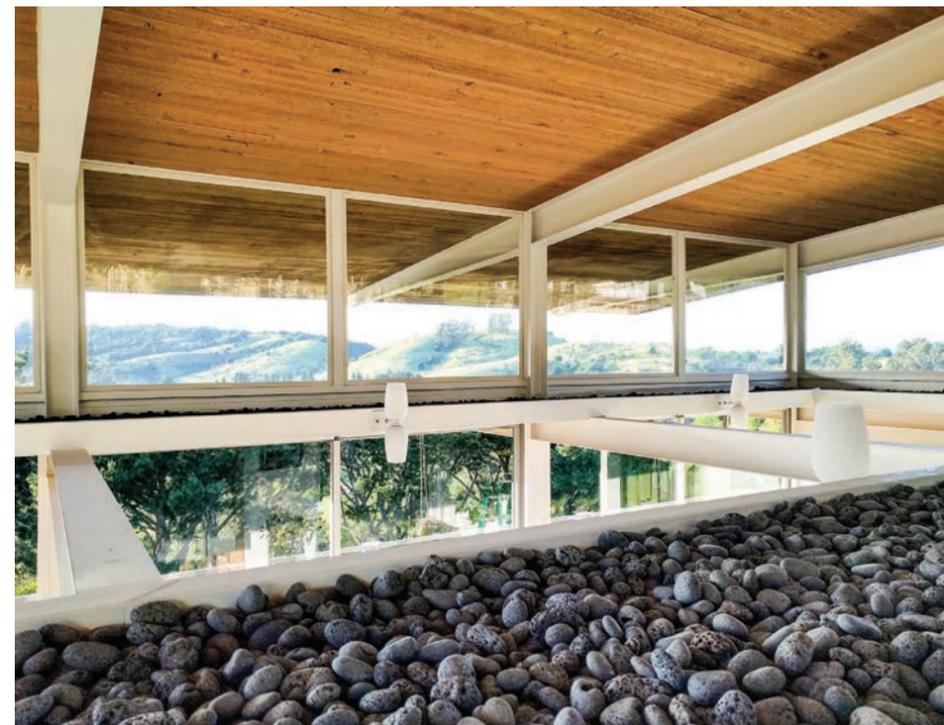
THE CEILING OF #26 IS IN TWO LAYERS. A SLANTED CEILING WHICH FOLLOWS THE ANGLE OF THE HILL SLOPES DOWNWARD FROM THE CARPORT OVER THE HOUSE AND PROVIDES PROTECTION FROM THE ELEMENTS. THE CLERESTORY WINDOWS SIT JUST BELOW THIS AND ILLUMINATE THE INTERIOR. BENEATH THE CLERESTORY WINDOWS, A SERIES OF BEAMS SUPPORT A LOWER, PARTIALLY OPEN CEILING THAT ACTED AS A CATWALK WHILE CORD AND ALFONSO INSTALLED THE INDOW INSERTS. AFTER INSTALLATION, THE PARTIAL CEILING WAS FILLED WITH LAVA ROCK TO ADD TEXTURE.
